SAFETY NOTICE

Reserve handle check is required for PROGRESS 3 & EASINESS 2 harnesses

Instructions for the PROGRESS 3 and EASINESS 2 reserve parachute handle check

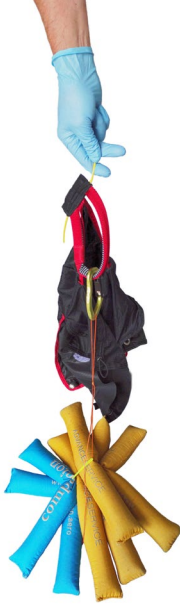
1. Pull the reserve out of the harness.	
2. Take the reserve parachute out of its inner container.	
3. Attach the weight 10-12 kg to the reserve handle by a carabiner and/or line.	
4. Put on a glove so that the yellow cable does not slip out of your hand, grasp it on one side of the handle and lift it until the entire weight is lifted from the ground.

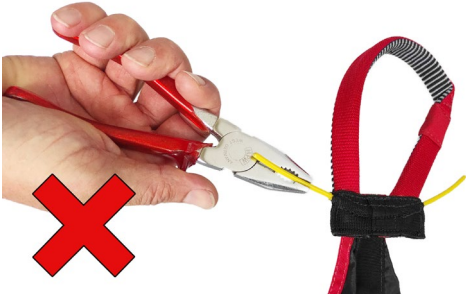
5. Repeat step 4 with the yellow cable on the other side of the handle..	
IMPORTANT: The yellow cable must not be gripped with pliers or similar metal devices. This can damage its smooth surface and jamb subsequent releases.

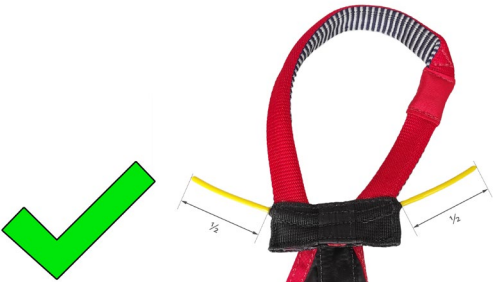
<p>1. The cable must not have any play or be able to be moved off centre. A minimal movement of approx. 2 mm is permissible due to the elasticity of the fabric.</p>

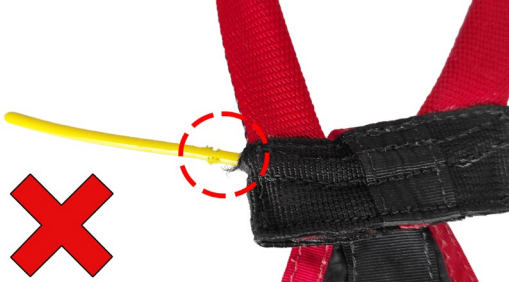
<p>2. If the cable can be pulled out on one side and not on the other, the handle and container must be replaced.</p>	
<p>3. If the cable can be moved such that its sewing or threads are visible or frayed, the handle and container must be replaced without question.</p>

<p>4. Replace the container if you are not sure. This applies for any uncertainty, if you suspect point 2 or 3 or the test is inconclusive.</p>

If the test fails and the reserve parachute handle needs to be replaced, you can order it free of charge by stating the serial number at www.advance.swiss/en/recall/progress3_easiness2
